August 2022 - Revision 4: This issue supersedes all previous issues

# Exhaust from wood and oil fire burners

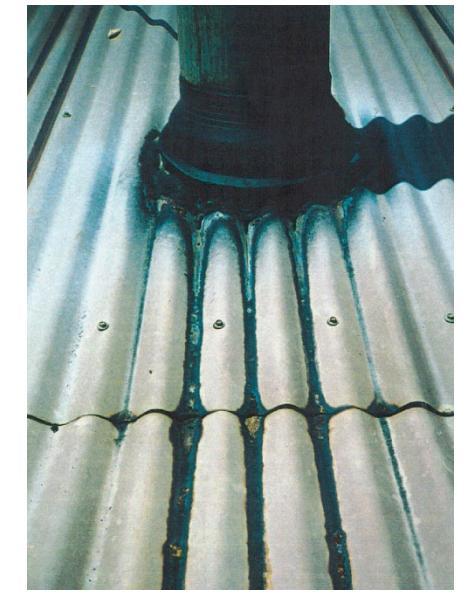
#### Figure 1: Flue Deposition/Corrosion

Corrosion arising from deposition from incorrectly designed flues has been found to be related to grossly elevated concentrations of sulphurous products, wood acids and resinous combustion products which have condensed directly from the flue gas. This has been found to be related to fuel type, and/or inappropriate flue design.

Where the skin temperature of the flue is low due to poor design or the use of single tube flue systems, cooling of the flue gas will occur. This results in precipitation of the flue gas components and deposition of the heavier particles on the roof surface adjacent to the flue.

The fallout from boilers and heaters using wood and oil for fuel can be unsightly and, if neglected, damage the surface on which it falls. While it is not always possible to prevent this happening, it can be reduced by locating the flue or exhaust in a position where prevailing winds would blow the fallout clear of the roof. It is most important to ensure that the height of the flue is sufficient to create a good draft which will also result in reducing the concentration of the fallout on the roof.

The design of the flue must meet the appropriate Australian/New Zealand Standard AS/NZS 2918:2018 *Domestic solid fuel burning appliances – Installation* and meet appropriate local government building ordinances.
