Following trades

Introduction

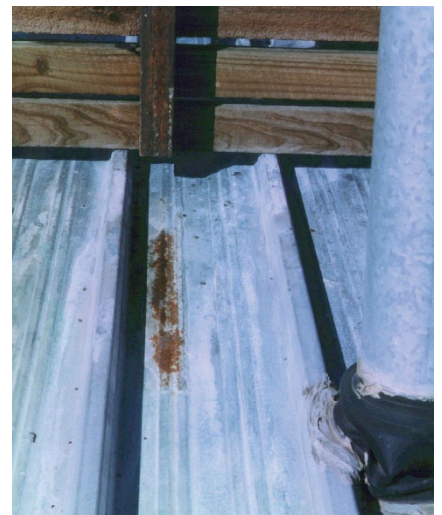
Figure 1: Treated Timber Walkway

Other potentially unsuitable materials may include timbers or similarly cellulose materials (open-cell foam for example) that can be prone to absorbing moisture that may in turn be retained against the surface of roof sheets for prolonged periods. Extended time of wetness can be a major influence of corrosion mechanisms. Like incompatible metals, water runoff from some treated timbers can also be detrimental to corrosion performance of roof sheets. Where timbers are likely to result in water runoff over roof sheets, mitigation actions through isolation (painting of timber) or water runoff management should be taken. Please refer to:
