# Inert catchment

The information and advice contained in this Technical Bulletin ('Bulletin') is of a general nature only and has not been prepared with your specific needs in mind. You should always obtain specialist advice to ensure that the materials, approach and techniques referred to in this Bulletin meet your specific requirements. BlueScope Steel Limited makes no warranty as to the accuracy, completeness or reliability of any estimates, opinions or other information contained in this Bulletin and to the maximum extent permitted by law, BlueScope Steel Limited disclaims all liability and responsibility for any loss or damage, direct or indirect, which may be suffered by any person acting in reliance on anything contained in or omitted from this Bulletin. COLORBOND® and ZINCALUME®, BlueScope and the BlueScope brand mark are registered trademarks of BlueScope Steel Limited. © 2022. BlueScope Steel Limited ABN 16 000 011 058. All rights reserved.

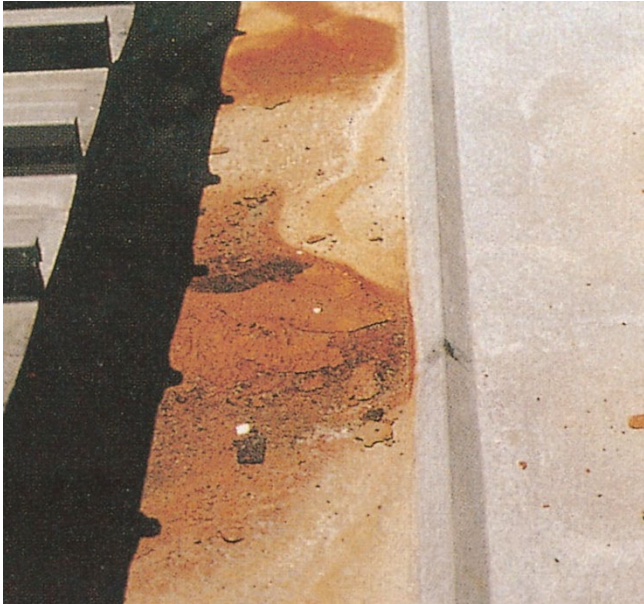
**Figure 1: Severe corrosion caused by ponding and the use of zinc-coated gutters in combination with roofing of both ZINCALUME® steel and COLORBOND® prepainted steel**

- COLORBOND® steel and ZINCALUME® steel roofing with zinc-coated steel gutters and downpipes
- Prepainted zinc-coated steel roofing with unpainted zinc-coated steel gutters

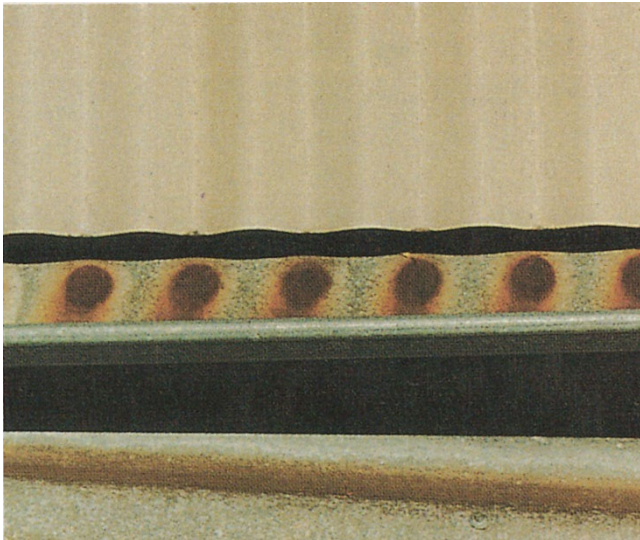
**Figure 2: Prepainted zinc-coated steel roofing with zinc-coated steel gutters**

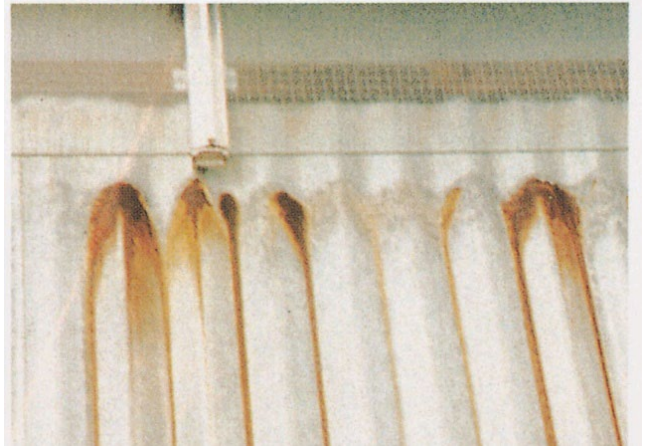
**Figure 3: Water flowing from a glass roof onto zinc-coated steel roofing**

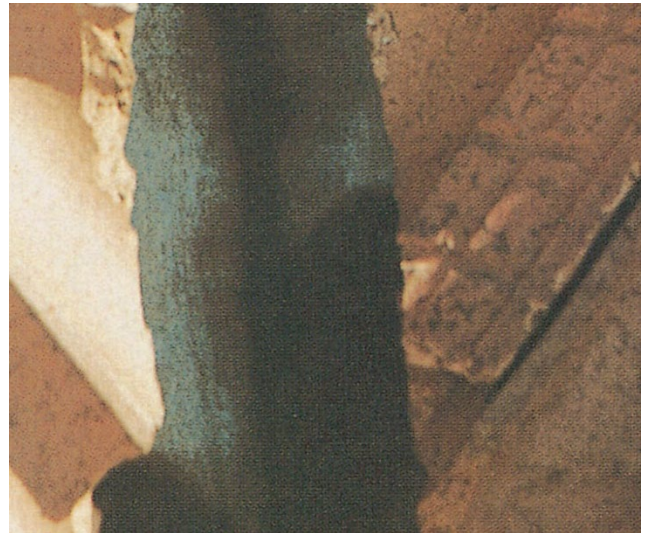
**Figure 4: Water flowing from a terracotta roof into zinc-coated steel gutter**

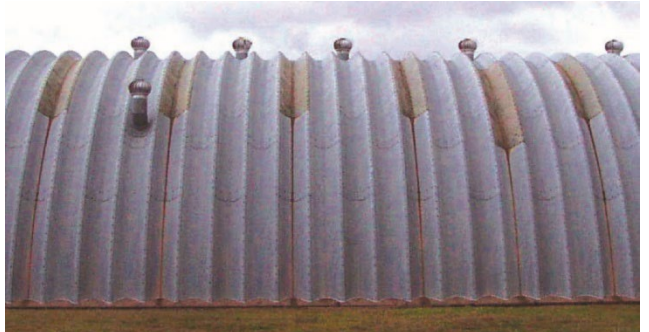
**Figure 5: Fibreglass skylights in conjunction with zinc-coated steel sheeting**
