Cut edge and bend protection of next generation ZINCALUME® steel and COLORBOND® steel

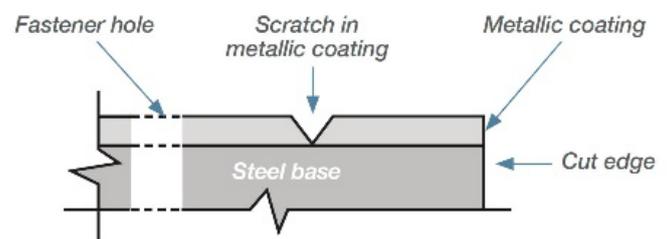
Figure 1. Schematic of a cut edge (not to scale)

Unprotected edges are created on coated steel products when the sheet is cut or pierced. Examples include when roofing or walling is cut to length or when holes are made in the steel to accommodate fasteners. It is normal practice to have edges that have been slit, sheared, drilled or cut on site using a cold cutting saw. Figure 1 shows a schematic of a cut edge.

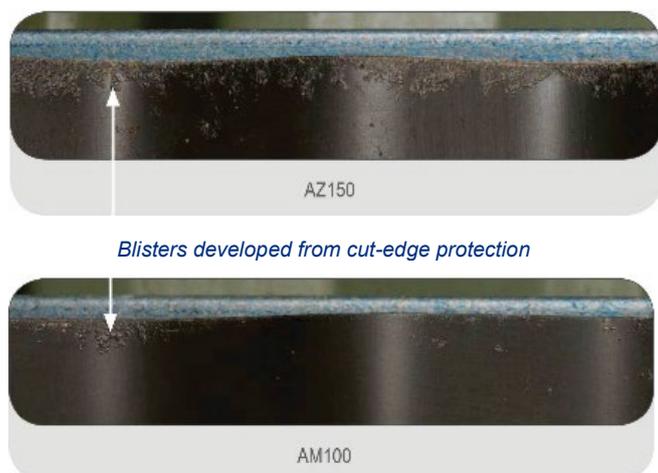
Figure 4. Prepainted sheltered walling (unwashed) in a severe marine environment after 50 months.

NOTE: The samples shown in Figure 4 have been tested in a severe environment to accelerate corrosion rates. Use of the product in this location is not recommended by BlueScope

While prepainted AZ150 provides excellent cut edge protection, next generation COLORBOND® steel with Activate® technology provides an even more effective means for protecting cut edges. A reduction in metallic coating is able to be achieved without compromising the corrosion resistance at the cut edges of the prepainted product. This is illustrated in Figure 4.

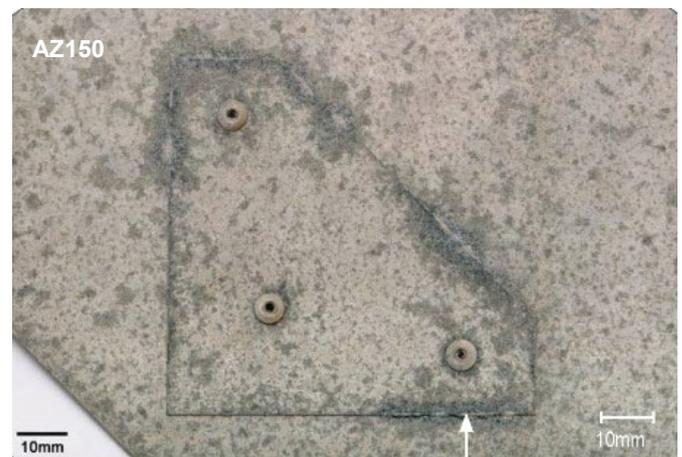
Figure 3. Unpainted panels tested in a sheltered (unwashed) position in a severe marine environment after 66 months

Dark areas indicate metallic coating corrosion originating from the cut-edge.

NOTE: The samples shown in Figure 3 have been tested in a severe environment to accelerate corrosion rates. Use of the product in this location is not recommended by BlueScope

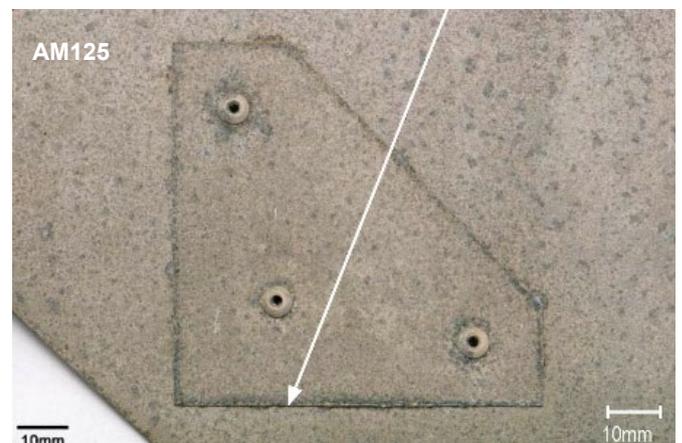
Figure 2. Unpainted sheltered walling (unwashed) in a severe marine environment after 50 months.

Dark areas indicate metallic coating corrosion originating from the cut-edge.

NOTE: The samples shown in Figure 2 have been tested in a severe environment to accelerate corrosion rates. Use of the product in this location is not recommended by BlueScope.

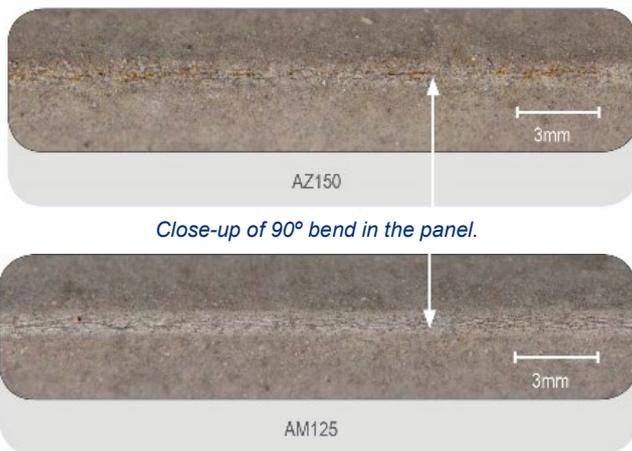
Figure 5. Close-up photographs of the 90° bend of unpainted samples exposed in a marine environment after 18 months (washed).

NOTE: The samples shown in Figure 5 have been tested in a severe environment to accelerate corrosion rates. Use of the product in this location is not recommended by BlueScope.

Extensive test programs have shown that the enhanced corrosion protection provided by the AM coating maintains either equivalent or superior field corrosion performance compared with AZ, even if the surface has superficial cracking. Figures 5 and 6 show samples that have been tested outdoors in marine environments to determine the difference in bend corrosion performance between AZ and AM.

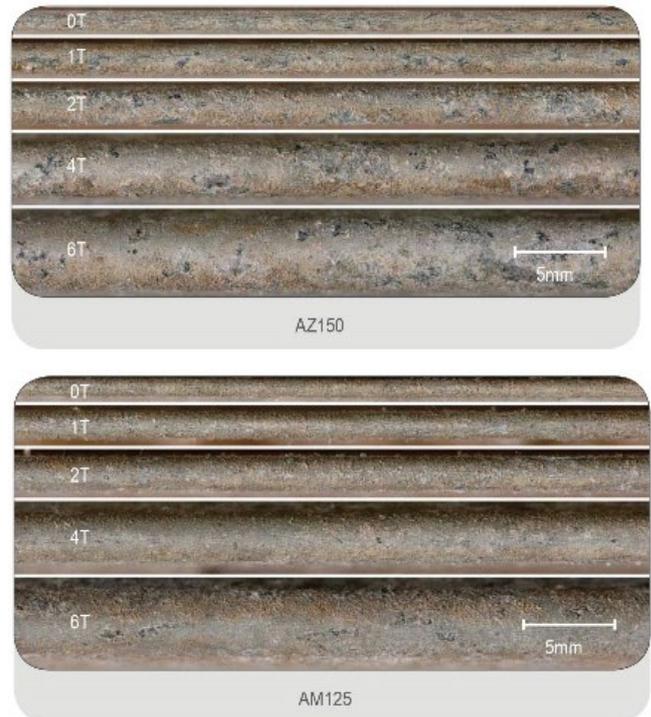
Figure 6. Unpainted samples of AZ and AM with various bend diameters, exposed in a sheltered (unwashed) severe marine environment for 45 months.

NOTE: The samples shown in Figure 6 have been tested in a severe environment to accelerate corrosion rates. Use of the product in this location is not recommended by BlueScope.

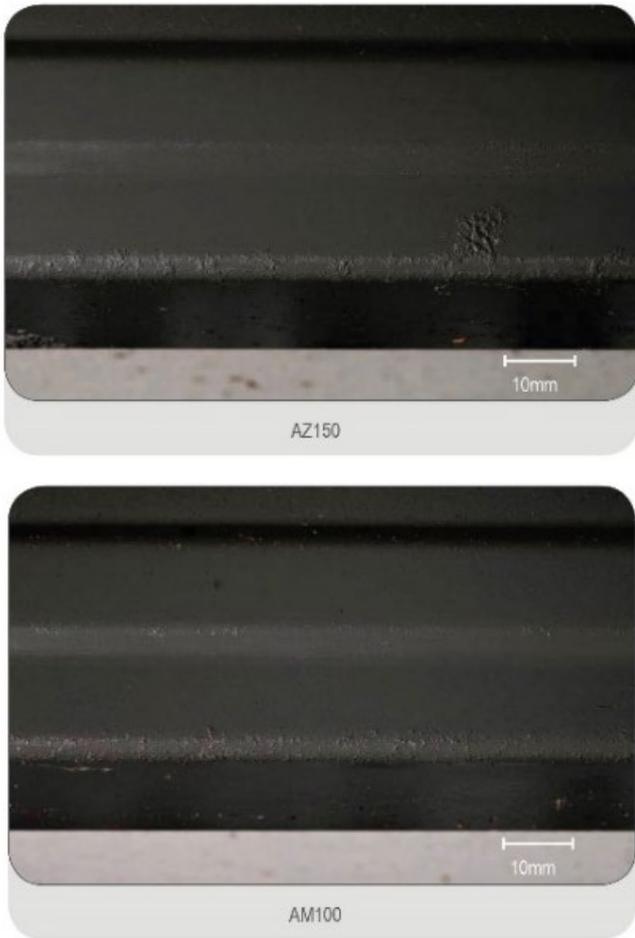
Figure 7. Prepainted, sheltered fascia bends (unwashed) after 57 months exposure within 100m from breaking surf on an outdoor test facility.

NOTE: The samples shown in Figure 7 have been tested in a severe environment to accelerate corrosion rates. Use of the product in this location is not recommended by BlueScope

Bend corrosion performance on prepainted products is most relevant to applications with relatively tight bends that are also in unwashed areas. Figure 7 shows fascia samples of prepainted AZ150 and AM100 that have been tested in a severe marine environment for 57 months. Both samples show a number of very small blisters (visible at 10x magnification), with additional intermittent larger blisters on the AZ150 product. It is important to note that the level of blistering seen in Figure 7 is not typically observed on either AZ or AM alloy coated steels in less severe environments. Figure 8 shows the results of a test to determine the corrosion performance of prepainted AZ150 and AM100 with a range of bend radii, exposed for 51 months in an unwashed marine environment. Whilst there is slightly more cracking on the AM100 product, there is a minimal corrosion on either the AZ150 or AM100.

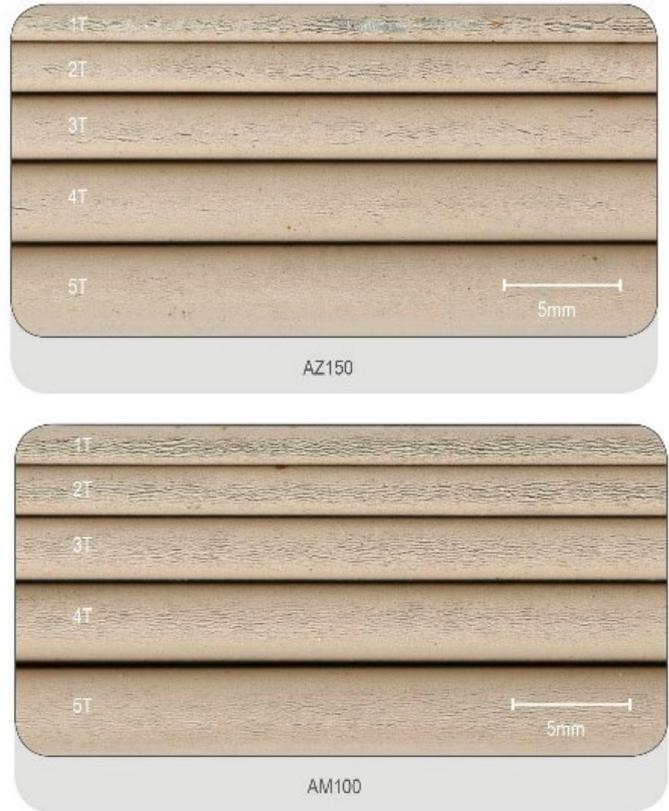
Figure 8. Prepainted bend samples exposed in an unwashed marine environment for 51 months.

NOTE: The samples shown in Figure 8 have been tested in a severe environment to accelerate corrosion rates. Use of the product in this location is not recommended by BlueScope
