Effect of touch-up paint

Introduction

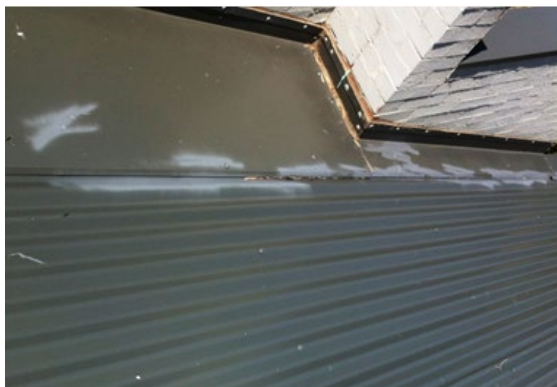
During manufacture, COLORBOND® prepainted steel undergoes a curing process in which the paint is baked onto the metallic coated steel substrate; while other paint systems, for example aerosol sprays, are air dried. Air-drying paints have different weathering characteristics to oven cured, prepainted products like COLORBOND® steel. Therefore, areas overpainted with air-drying paints to match adjacent COLORBOND® steel areas will weather at a different rate and vary in appearance over time (Figures 1 and 2).

Figure 1. Irregular faded appearance of touch-up paint on roof flashing and roofing broad sheet

BlueScope does not recommend the use of touch-up paint to repair damage or scratches to the painted surface. As explained above, air-drying paints have different weathering characteristics to COLORBOND® steel, which leads to variations in appearance over time where touch-up paint has been used. BlueScope does not have a recommended method for the removal of touch-up paint. Minor scratches (< 2mm in width) should be left alone as the available metallic coating will continue to protect against corrosion providing the scratches are superficial and the metallic coating is not damaged. If scratches are more noticeable on new material, it is the recommendation of BlueScope to replace the affected product.

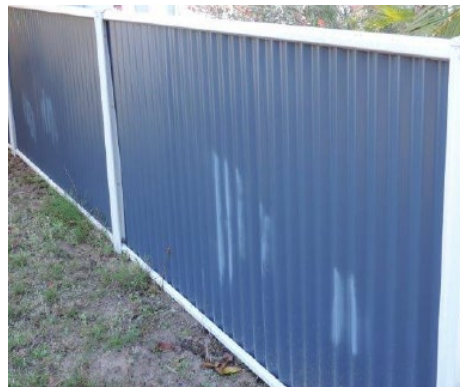
Figure 2. Irregular faded appearance of touch-up paint on fencing panels

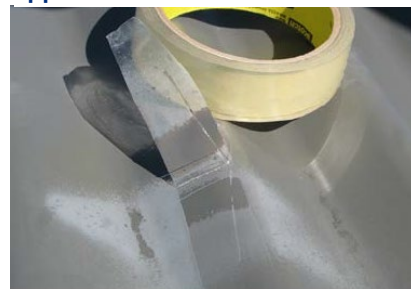
Adhesive tape can be pressed onto the surface of the defect and rapidly removed. Upon removal the tape may show retained paint on its adhesive surface. Where the tape has been removed from the material, the faded area is also removed showing the original colour underneath (Fig. 3).

Figure 3. Tape-off showing colour of original painted surface beneath a removed surface layer of faded appearance

The application of touch-up paint, after installation of the various COLORBOND® steel components, can explain the irregular faded appearance of the COLORBOND® steel. The relative ease with which the surface layer is removed to reveal the original colour beneath (via adhesive tape and/or rubber eraser) is another indication that touch-up paint has been used.

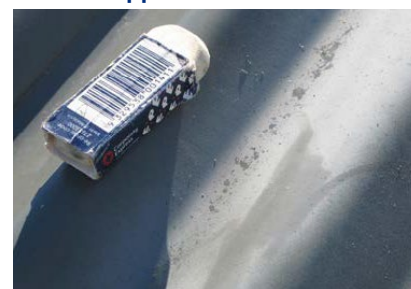
A rubber eraser can be used on a section of the material that has the faded appearance. This test will show the partial removal of the faded surface layer revealing the colour of the original painted surface beneath (Fig. 4).

Figure 4. Rubber eraser showing colour of original painted surface beneath a removed surface layer of faded appearance
